ALABAMA DEPARTMENT OF ENVIRONMENTAL MANAGEMENT  
 WATER DIVISION – INDUSTRIAL AND MUNICIPAL SECTIONS  
**NONCOMPLIANCE NOTIFICATION FORM**

PERMITTEE NAME: Prudes Creek WWTP PERMIT NO: AL0056120  
 FACILITY LOCATION: 500 Water Trail Graysville, AL 35073 (Jefferson County)  
 DMR REPORTING PERIOD: September 2015

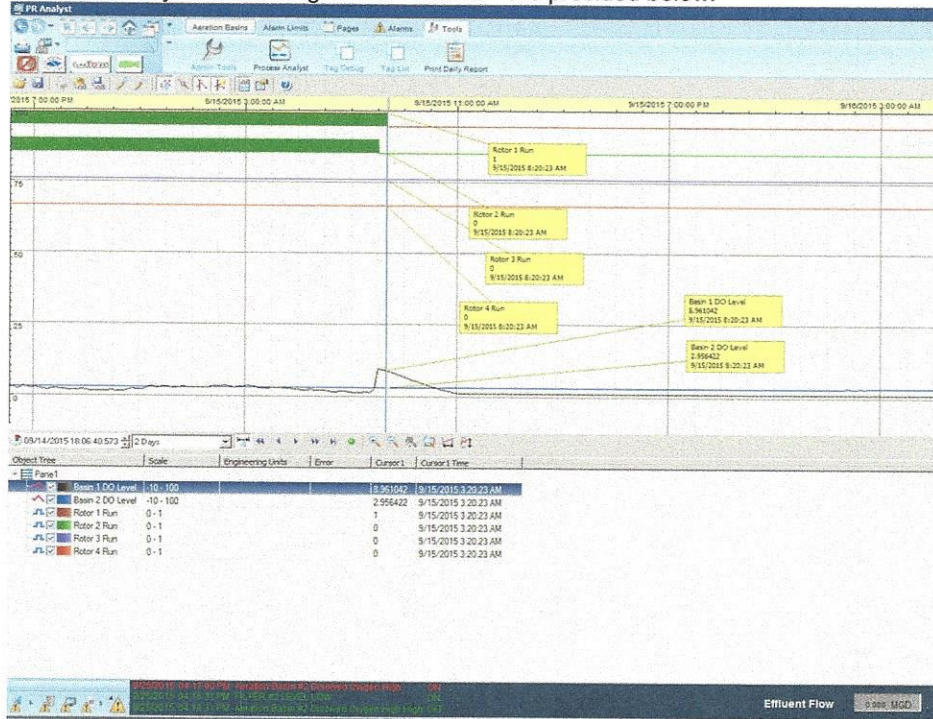
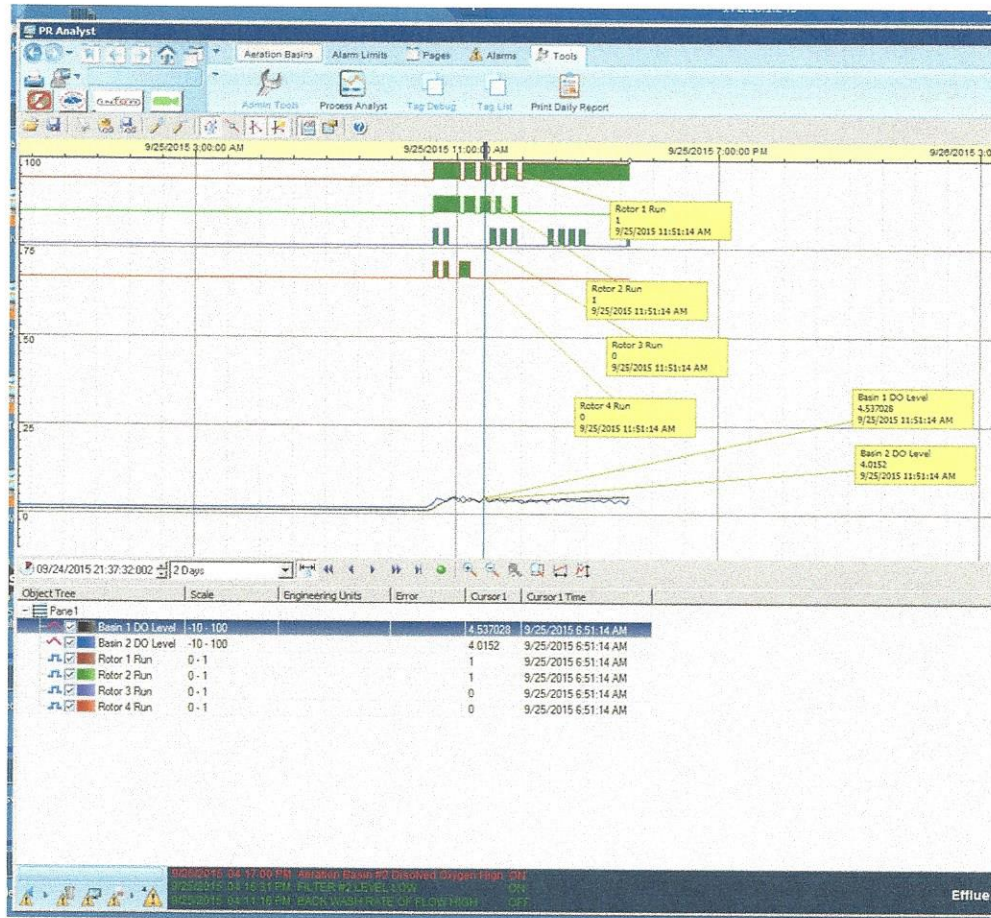
Between Tuesday September 15, 2015 and September 25, 2015, the DO probe on Aeration Basin #1 began to consistently display a false reading between 1.05 and 1.10 mg/l which is above the set-point that would have turned the rotors on if they had been running in the automatic control position. The DO readings are believed to be false because there were almost no variation between the minimum and maximum values recorded during this period. Aeration Basin #2 also showed unreliable DO readings. Per the logs in the SCADA system historian, the two brush rotors in Aeration Basin #1 and the two in Aeration basin #2 did not operate from 8:20 a.m. on September 15<sup>th</sup> until 10:15 a.m. on September 25, 2015 when they were found in the SCADA Manual (off) setting. Upon discovery, the rotors were changed to automatic control and began running. The operators who worked between the 15<sup>th</sup> and 25<sup>th</sup> failed to recognize the rotors were in an off-state and did not run despite recording data which indicated zero run hours on their daily log sheets. During this ten day period, the aerobic nitrifying bacteria were likely stressed by the low DO conditions that had developed, even though there were no indications of anaerobic conditions reported by the operators in Aeration Basin #1 or Aeration Basin #2.

Screen shots from the SCADA system showing the 15<sup>th</sup> and 25<sup>th</sup> are provided below.

Concurrent with the operational plans developed on the 25<sup>th</sup>, ESD management mobilized the electrical and instrumentation maintenance groups to investigate and correct the DO and TSS meter calibration and performance problems and the rotor run-time issues. The WWTP staff was later directed to pull the daily log sheets with the recorded run time for each rotor to provide additional data to determine the possible time frame for the rotor instrumentation failures.

The operators were instructed to include daily verifications of the installed DO meters using a portable meter calibrated to low DO levels. The effluent DO sample practices were reviewed with the operators, and it was found that the sample point has been prior to cascade post aeration. The relocation of the DO sample location to a point closer to the receiving water is under review by ESD management.
